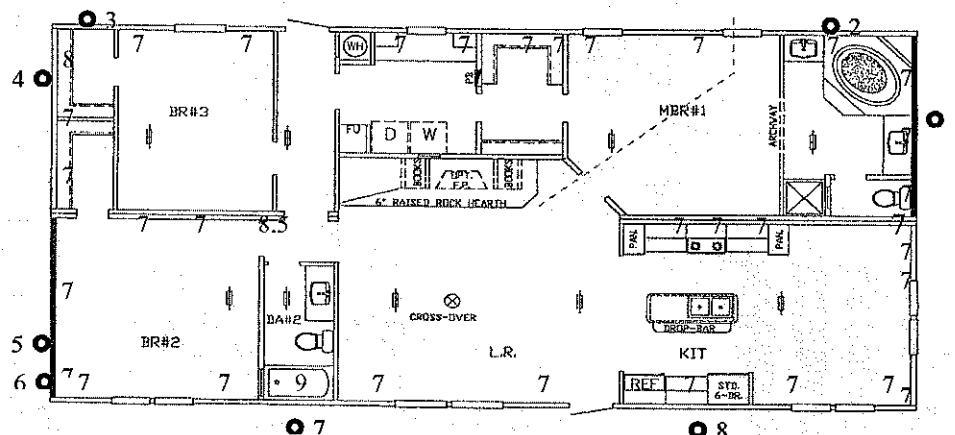
Figure 5. ● Wall cavity sample locations for moisture level readings. 7, etc. Relative moisture readings from inside home
